Manhole Inspection Summary

Manhole # S19I__037MH

Insp Date: **9/28/07 9:36 AM**

Location Address: **2047 HOLLINS-BOYD**

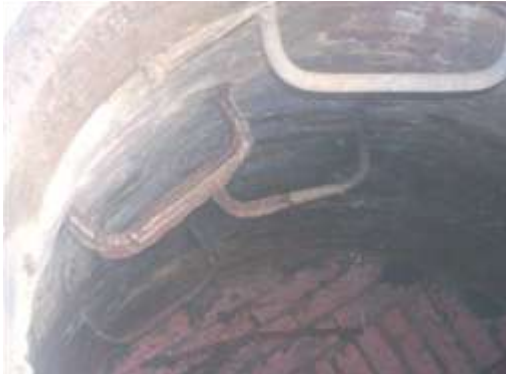
Defect 3

Count: **4** Missing: **0** ☒ **Corroded**

CORRODED STEPS

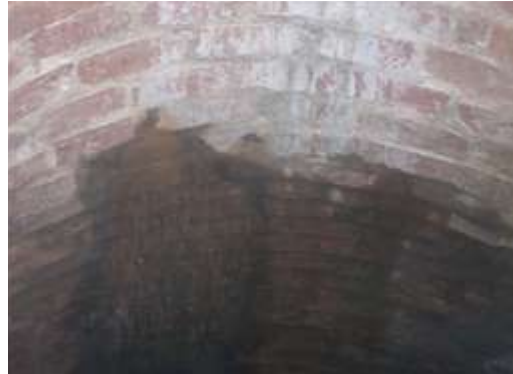
Defect 2

Infiltration: ☐ None ☐ Joint ☐ Cracks ☐ Mortar ☐ Roots ☒ **Wall**

CORBEL WALL INFILTRATION

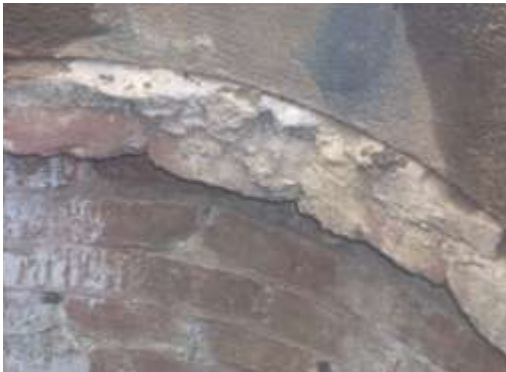
Defect 1

Condition: ☐ Sound ☐ Cracked ☐ Root Intrusion ☐ Loose Brick ☒ **Deteriorated**

CHIMNEY DETERIORATION

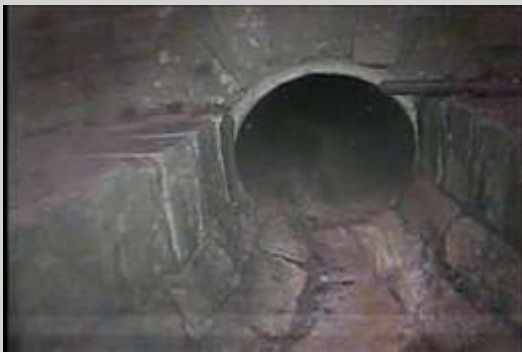
12 O'Clock Outflow

Pipe Height: **8.4** (in.) Rod and Bar (Angled)
Pipe Material: **Clay** ☐ Pipe Lined
Invert Depth: **8.56** (ft.) Flow Characteristics: **Slow**
Deposits: ☒ None ☐ Mud ☐ Sludge ☐ Debris ☐ Grease
Silt Depth: (in.) Deposits Extent:
Infiltration: **None** Pipe Seal Cond: **Sound**

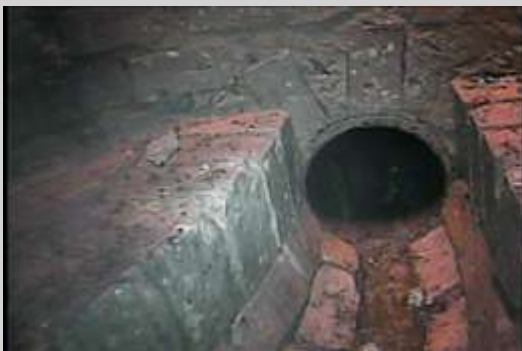
3 O'Clock Inflow

Pipe Height: **6** (in.) Rod and Bar (Angled)
Pipe Material: **Clay** ☐ Pipe Lined
Invert Depth: **8.43** (ft.) Flow Characteristics: **Slow**
Deposits: ☒ None ☐ Mud ☐ Sludge ☐ Debris ☐ Grease
Silt Depth: (in.) Deposits Extent:
Infiltration: **None** Pipe Seal Cond: **Sound**

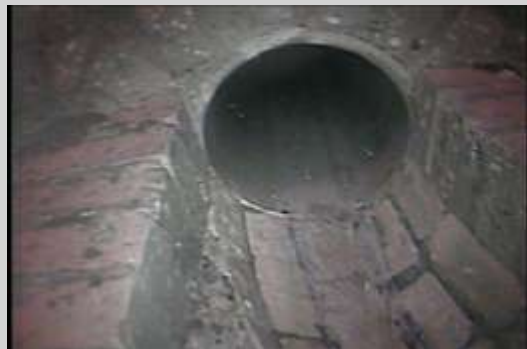
9 O'Clock Inflow

Pipe Height: **8.4** (in.) Rod and Bar (Angled)

Infiltration: **None** Pipe Seal Cond: **Sound**
